**INCIDENT NUMBER: 12-E-CBX**

**STATE OF WASHINGTON  
DEPARTMENT OF NATURAL RESOURCES  
Southeast Region  
WILDLAND FIRE INVESTIGATION REPORT**

**FIRE NAME:** Taylor Bridge Fire

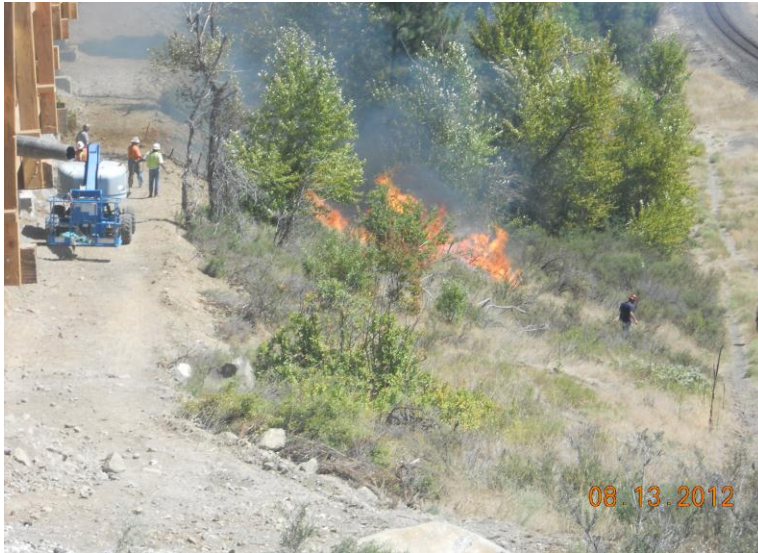
*(Picture003.jpg taken by Otero)*

Otero stated at approximately 1330 hrs. he heard someone shout “fire” on the job site. He was on Highway 10 on the west end of the bridge’s job site and looked to the east below the bridge. He said he observed a fire burning in the grass and brush below the bridge. He photographed it as it progressed. However, it should be noted he actually called 911 at approximately 1319 hrs. to report the fire and first observed the fire approximately 5 minutes prior to reporting it (approximately 1314 hrs.). He stated the fire was approximately 15 feet in diameter when he called the fire department. See Otero’s written statement and copies of the photos he took of the fire. (See attachment G1-KITTCOM CAD Log and attachment E6 Otero Statement).
